Manhole Inspection Summary

Manhole # S25GG1028MH

Location Address: **4013 FALLS RD**

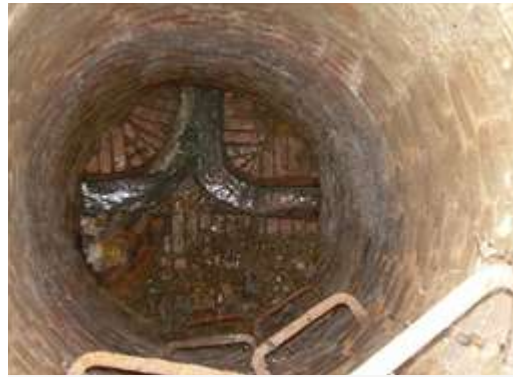
Top View

Corroded steps. Evidence of surcharge - Bench debris.

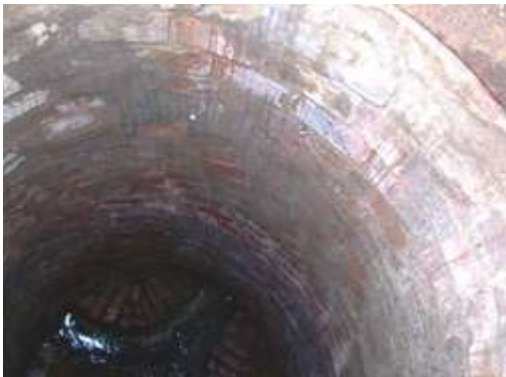
Defect

Frame leaks. Adjustment and Barrel infiltration.

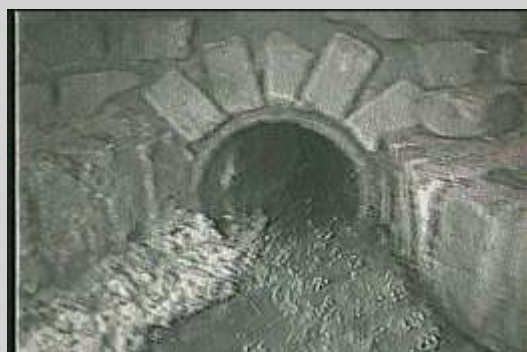
Pipe Out @ 12 O'Clock

Deposits: ☐ None ☐ Mud ☐ Sludge ☒ **Debris** ☒ **Grease**

Infiltration: **Evidence**

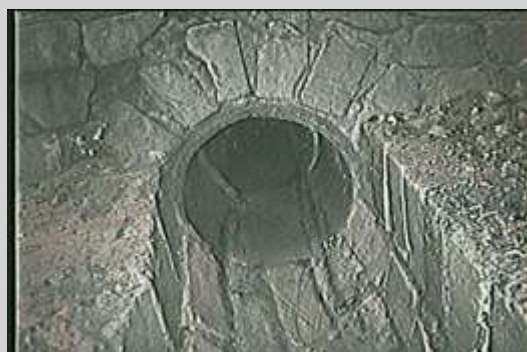
Pipe In @ 3 O'Clock

Barrel deterioration and infiltration. Channel deterioration.

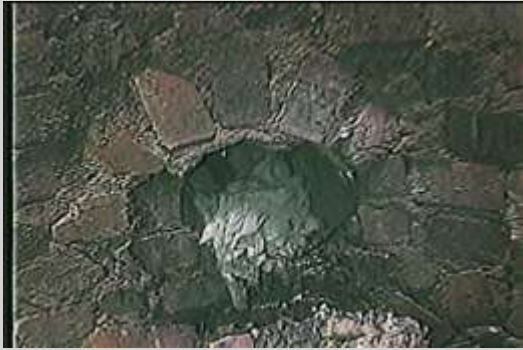
Pipe In @ 7 O'Clock

Barrel deterioration and infiltration.

Pipe Seal Cond: **Broken**

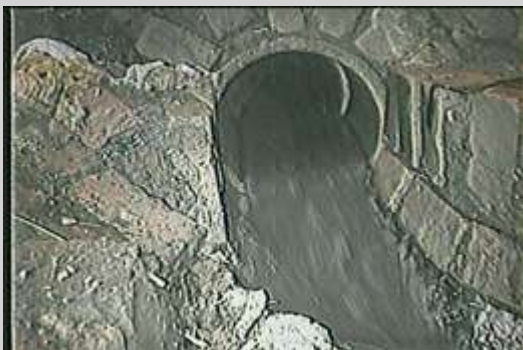
Pipe In @ 9 O'Clock

Channel deterioration.
